MTL TR 91-33

LAV STRUT CAP STUDY

September 1991

US ARMY
LABORATORY COMMAND
MATERIALS TECHNOLOGY LABORATORY

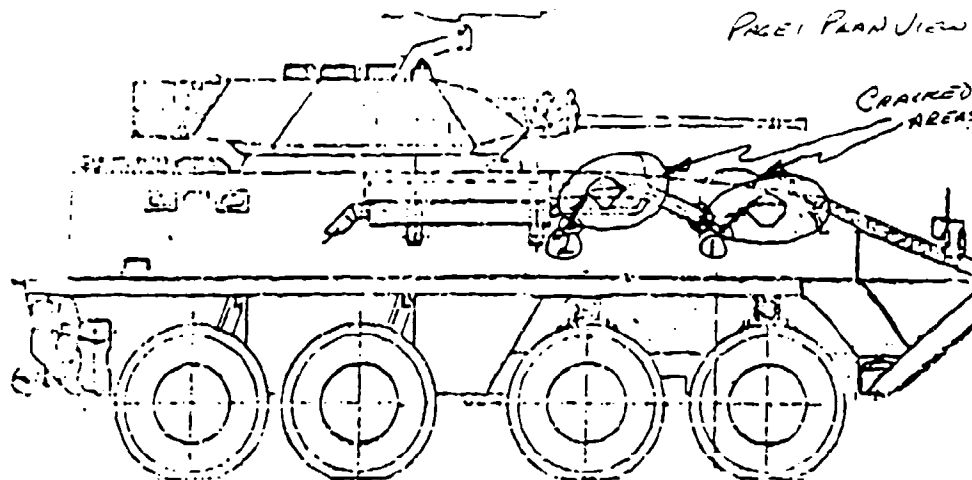
- CRACK LENGTH ① 3MM CRACK CRACK TYPE A
② 8MM UNDERBEAM CRACK TYPE C
- START/STOP POINT END OF WELD STRUT TO SIDESHEET TO
- COMMENTS VISUAL INDICATIONS FOUND WITH PNEUMATIC

Figure 4. A typical example of a Field Service Report with weld cracks in the strut caps.

① INDICATION REMOVED BY GRINDING. NO
(WELDING REQUIRED). EXCAVATION LPI CHECK-
② INDICATION REMOVED BY GRINDING
AND EXCAVATION LPI CHECKED - ACCEPT.
AREA WAS REWELDED AND LPI CHECK.
ACCEPT PAINT TOUCH UP COMPLETED
